ARBORICULTURAL ASSESSMENT & IMPACT REPORT

HILL STREET DUNDALK CO. LOUTH

Project No. Date Revision
TDUN013 01/11/23 A

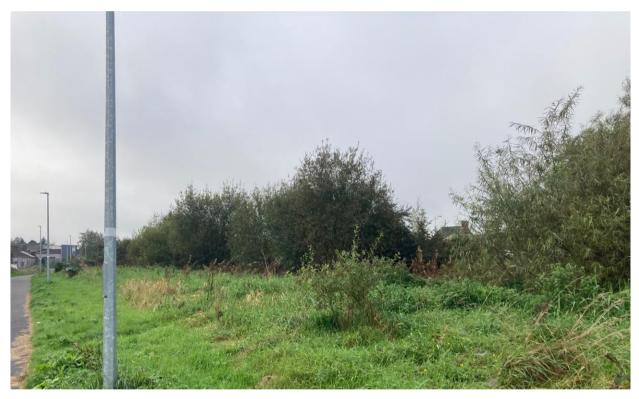
Image 2. Typical view of scrub vegetation on the western section of the site from the public path

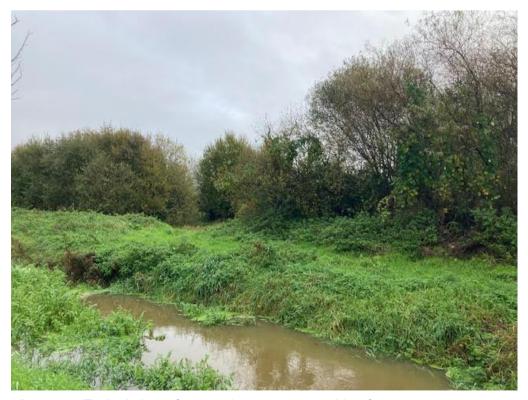
The section of the site to the eastern side of the public path is also populated with scrub vegetation (image 4). As the ground conditions in this area are wet the vegetation is mainly composed of willow (*Salix alba*). One dead sycamore is located adjacent to the path.

Image 4. Typical view of vegetation on eastern side of site
