ARBORICULTURAL ASSESSMENT & IMPACT REPORT

HILL STREET DUNDALK CO. LOUTH

Project No. Date Revision
TDUN013 01/11/23 A

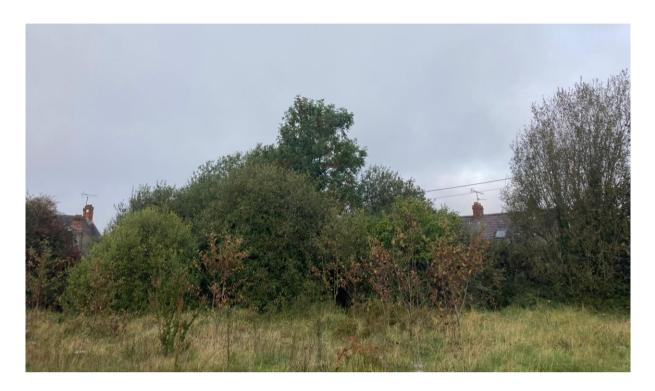
derelict parcel of land traversed by a public path. The western side of the site appears to have been stripped of soil in the past and is now becoming colonised by scrub vegetation (image 2) primarily composed of goat and white willow (*Salix caprea & Salix aba*) and buddleia (*Buddleia davidii*, image 2). The eastern section of the site is wetter with a higher predominance of white willow scrub (*Salix alba*).

Image 2. Typical view of scrub vegetation on the western section of the site from the public path
